# Manhole Inspection Summary

Manhole # S55I\_\_015MH

Insp Date: **5/28/08 2:26 PM**

**Location** Address: **534 s conkling st**

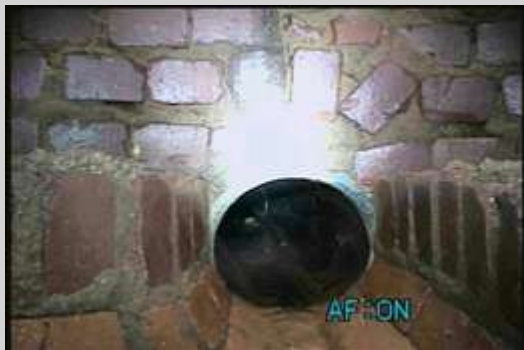
12 O'Clock Outflow

8 in. Circular Gravity Sewer  
Pipe Out @ 12 O'Clock

Pipe Material: **Clay** ☐ Pipe Lined

Invert Depth: **14.20** (ft.) Flow Characteristics: **Fast**

Deposits: ☒ None ☐ Mud ☐ Sludge ☐ Debris ☐ Grease

Infiltration: **None** Pipe Seal Cond: **Unknown**

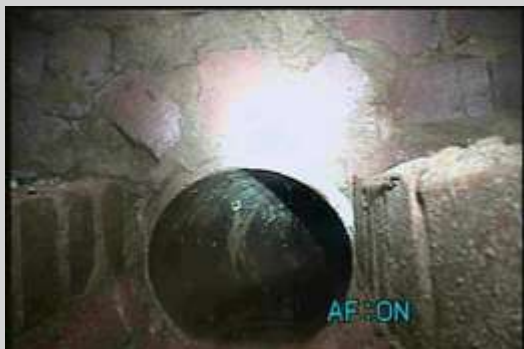
6 O'Clock Inflow

8 in. Circular Gravity Sewer  
Pipe In @ 6 O'Clock

Pipe Material: **Clay** ☐ Pipe Lined

Invert Depth: **13.82** (ft.) Flow Characteristics: **Slow**

Deposits: ☒ None ☐ Mud ☐ Sludge ☐ Debris ☐ Grease

Infiltration: **None** Pipe Seal Cond: **Unknown**

Connects To: **House connection / Service line**

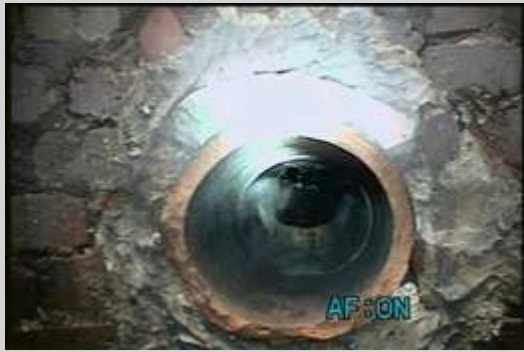
Pipe In @ 9 OClock

8 in. Circular Gravity Sewer

Pipe Material: **Clay** ☐ Pipe Lined

Infiltration: **None** Pipe Seal Cond: **Unknown**

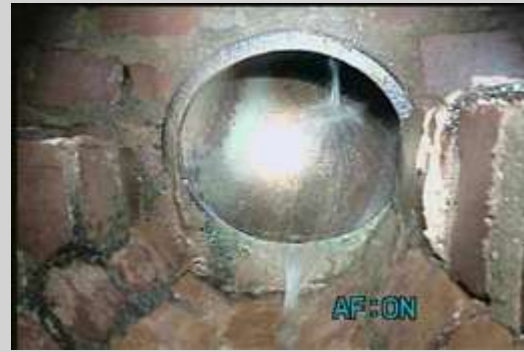
Drop In @ 9 OClock

Drop Condition: **Open**
